BELZONA® SEALS EXPANSION JOINTS IN CLARIFIER

PULP AND PAPER COMPANY
Skookumchuck, BC

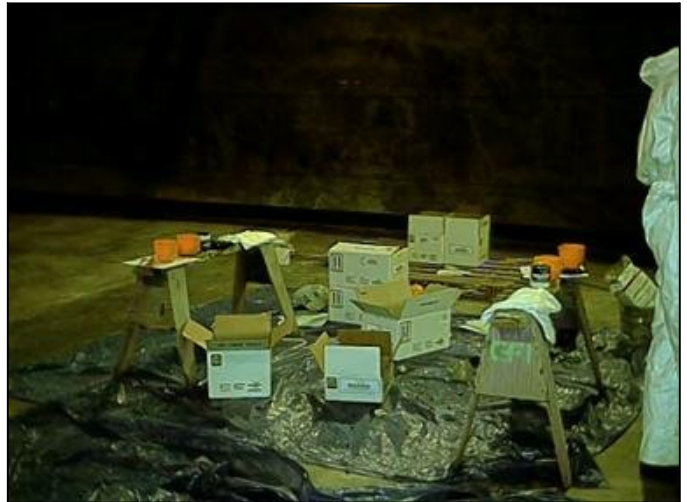
1. View of application in progress with product on site.
2. View of clarifier with some 1200ft of expansion joints.
3. Application in progress

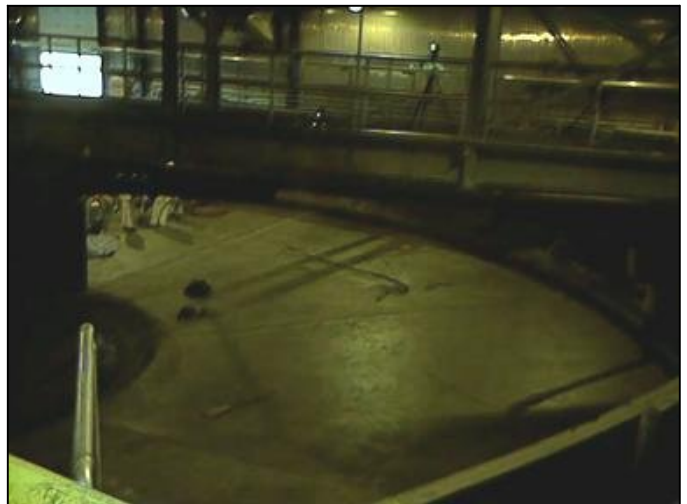
Original caulking material had failed creating an environmental seepage hazard.

The use of Belzona products allowed the mill rebuild damaged concrete and replace the 1200 feet of expansion joint material with a minimum amount of delay.
