BELZONA® SEALS STEEL PARTITION AT WASTEWATER PLANT

Wastewater Treatment Facility

July 2004

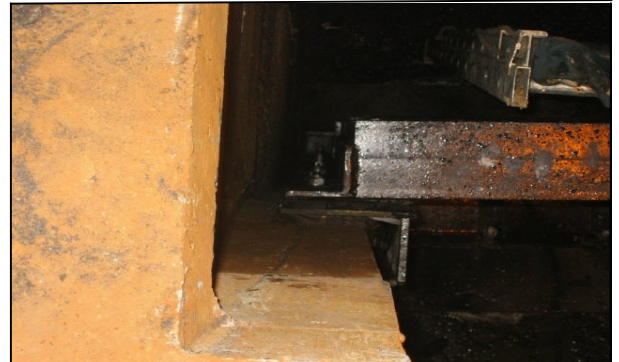
1. View of large gap between the partition and concrete wall.
2. Gap along bottom of partition was blanked off with some angle iron to create a dam in which to place the Belzona® 4111.
3. The bottoms of the vertical gaps were filled with Belzona® 4141 Magma Build and force cured with lamps before a wooden former was secured up the sides before the gaps were filled with Belzona® 4111 Magma Quartz.
4. Bottom seal being force cured while application on sides in progress.
