**BELZONA®
REPAIRS WASTEWATER PUMP**

Wastewater treatment Facility - Vancouver, Canada

Large six foot diameter centrifugal pumps.

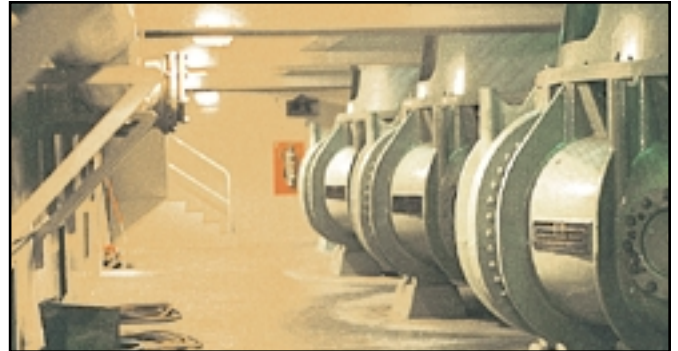
1. Overview of centrifugal pumps.
2. Pumps disassembled for repair.
3. Volute rebuilding in progress.
4. Rebuilding in progress, nearing completion.

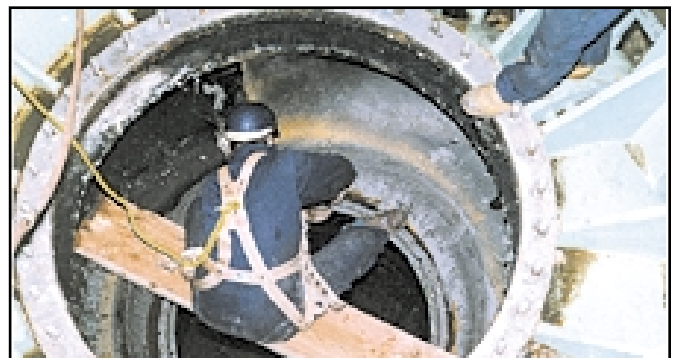
Pumps were suffering from severe erosion around the volute. It was difficult to remove the unit for repair due to its size and location.

Application was carried out in accordance with a modified version of Belzona Know-How System Leaflet CEP-5.
