BELZONA® ELIMINATES DAMAGE FROM CUI (CORROSION UNDER INSULATION)

Oil Refinery in U.K.

Outdoor condensate vessel.

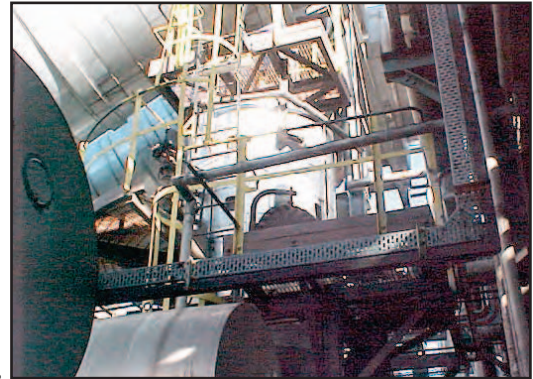
1. An overall view of the vessel, complete with lagging, while in service.
2. Surface preparation was carried out via wire brush and power wire-brushing tool.
3. Belzona® 5851 (HA-Barrier) is being applied via brush.
4. Close-up of application area. Showing brush strokes after one year of service.

The surface was prepared manually with a wire brush and a power wire brushing tool was used to remove loose particles. Belzona® 5851 (HA-Barrier) was applied by brush. Once the material cured, the vessel was re-lagged.
