BELZONA® PROTECTS FRACTIONATOR TOWER

Refinery in Singapore

Fractionator tower in cracker unit.

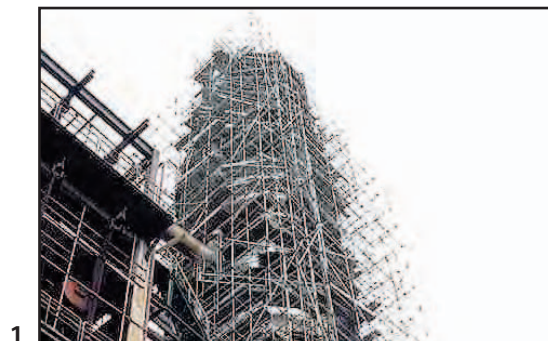
1. General view of the tower.
2. The degree of corrosion clearly evident on the support rings.
3. Application underway.
4. Application complete.

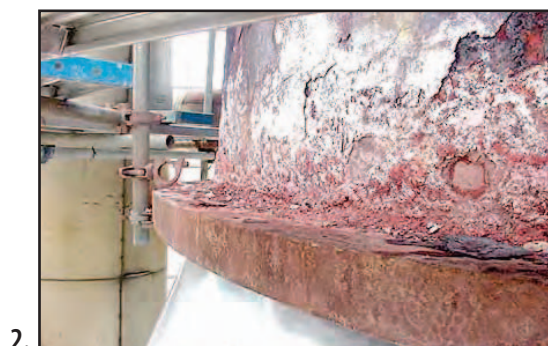
CUI (Corrosion Under Insulation) particularly around the support rings where moisture had accumulated.

The application was carried out in accordance with Belzona Know-How System Leaflet TCC-5. The insulation was removed from affected areas, substrate prepared and Belzona® 5851 (HA-Barrier) applied to the hot substrate.
