BELZONA® GETS THE NOD WHEN DOWNTIME MUST BE MINIMIZED

Geothermal Plant in the Philippines.

Anchor casing

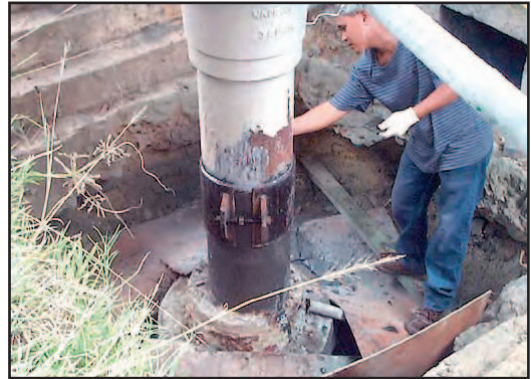
1. Pitted areas are rebuilt with Belzona® 1251 prior to Belzona® 5851 application.
2. Belzona® 1251 is heat cured in service with adhesion strength of 3200 psi.
3. Final coat of Belzona® 5851 for extra protection.

Manual surface preparation was used. Next, a new metal jacket was placed over the heavily pitted areas and bonded in place with Belzona® 1251. After the material began to cure, Belzona® 5851 was used to coat the entire area for extra protection.
