CORRODED PIPEWORK: A THING OF THE PAST WITH BELZONA[®] 5851 (HA-BARRIER)

Oil refinery in New Zealand

Corroded pipework and columns.

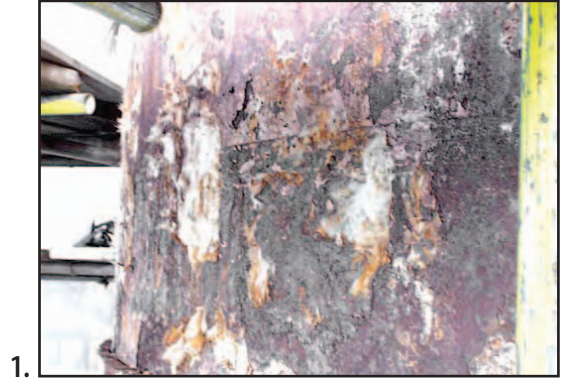
1. Prior to application, corrosion can easily be seen.
2. Belzona[®] 5851 (HA-Barrier) is easily applied to hot surfaces by trower, brush, or even spray.
