## BELZONA® SAVES LARGE SPLIT CASE PUMP

Coal Mine  
British Columbia

1996

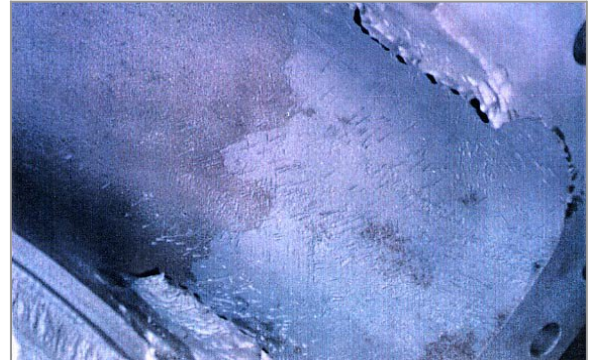
The splitter of this cast iron Worthington split case sludge pump had broken away. The mine engineers had originally discarded the "Belzona fix" and insisted that a new cast section be made and welded into place. This was duly done at great expense. The new splitter was "fared in" with Belzona® 1311 and the pump internals coated. After operating for only a few weeks the pump started producing a rattling sound and on further inspection it was found that the new splitter had come adrift and the only thing keeping it in place was the Belzona® product used to "fare it in". Because there was no replacement, it was decided to go ahead with the Belzona® repair originally suggested but turned down.

1. Photograph shows cast splitter missing. Note the evidence of the specialized welding.
2. Fabrication of new splitter in progress.
3. Fabrication of new splitter completed with the mesh area filled with Belzona® 1311 Ceramic R Metal.
4. Pump internals completely protected with 2 coats of Belzona® 1321 Ceramic S Metal.
