BELZONA® REBUILDS OVERSIZE PIN BUSH HOUSING

Mining Group
Tumbler Ridge, BC.

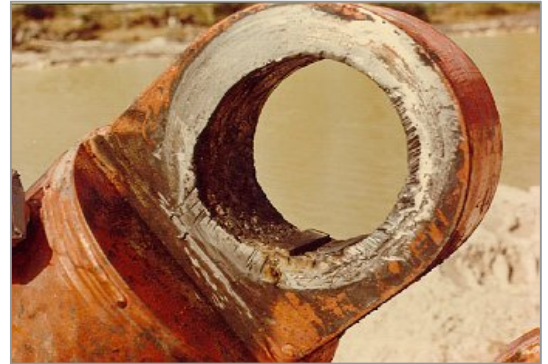
The bush housing had worn oversize

1. Oversize Housing.
2. Outer race used as a former
3. Trial fit
4. Completed application.
