## EMERGENCY REPAIR USING BELZONA®2311 - SR ELASTOMER

Mining operation

September 2005

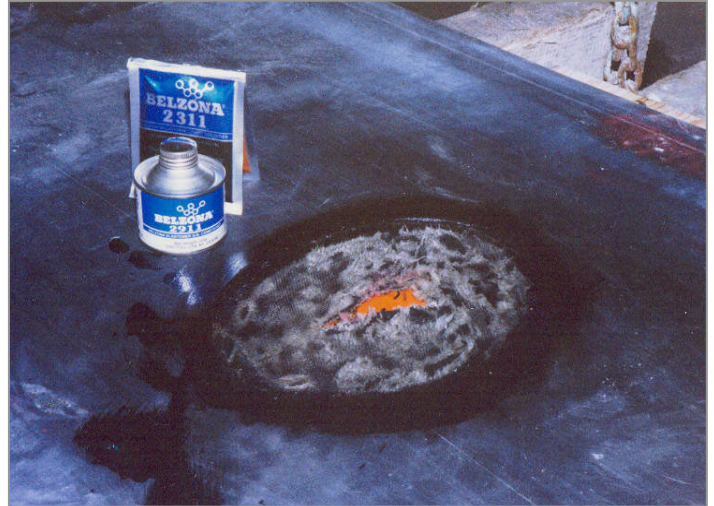
A large hole had formed in this conveyor belt stopping production

1. View of damaged conveyor belt showing the product used to make the repair.
2. Close up of repair area showing the use of the Belzona mixing surface positioned on the underside to act a suitable temporary backing for the repair.
3. Completed application

The use of Belzona® 2311SR Elastomer enabled maintenance to make the necessary repairs with the minimum amount of downtime and loss of production.
