BC KHIA # 006

BELZONA FPA-8 NON-SLIP SAFETY SYSTEM

General Hospital
Victoria, BC

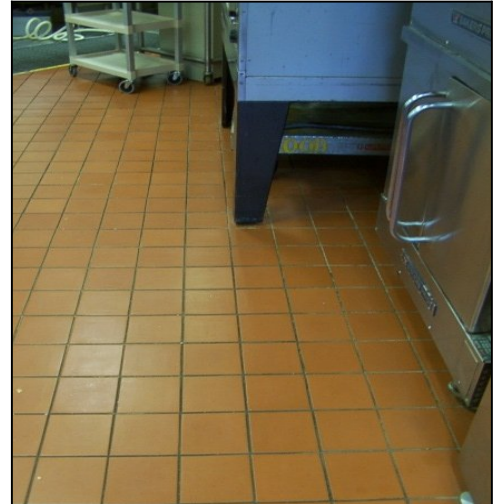
1. View of part of the application area
2. Application in progress in one of the stipulated areas.
3. View of another completed area.
