# KNOW-HOW *In Action*

BC KHIA # 011

## BELZONA® FPA-8 NON-SLIP SAFETY SYSTEM FOR TILED STAIRS

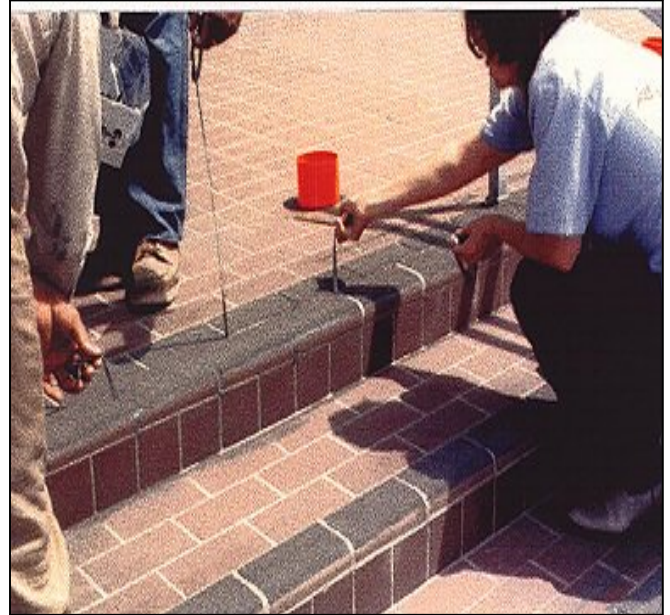
1. Application in progress
2. Completed application

Belzona® 4411 Granogrip

Application carried out in accordance with Belzona® Know-How Leaflets FPA-8
