KNOW-HOW *In Action*

BC KHIA # 076

INSTALLATION OF BELZONA FPA-8 NON-SLIP SAFETY SYSTEM

HOSPITAL KITCHEN
VICTORIA, BC

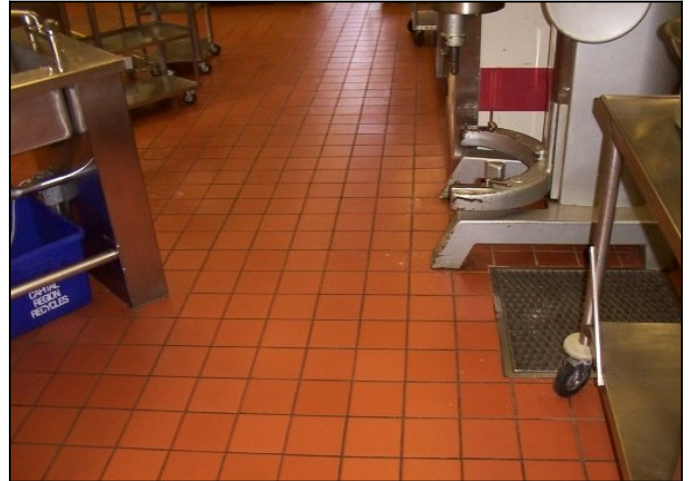
The tiled floor area presented a constant safety concern. Non-slip mats and other types of products were tried but did not provide a consistent long term solution to the problem.

1. View of floor area
2. Application in progress.
3. Completed application
