BELZONA® REFURBISHES EXPANSION JOINT MATERIAL

PROPERTY MANAGEMENT COMPANY
Shopping Center

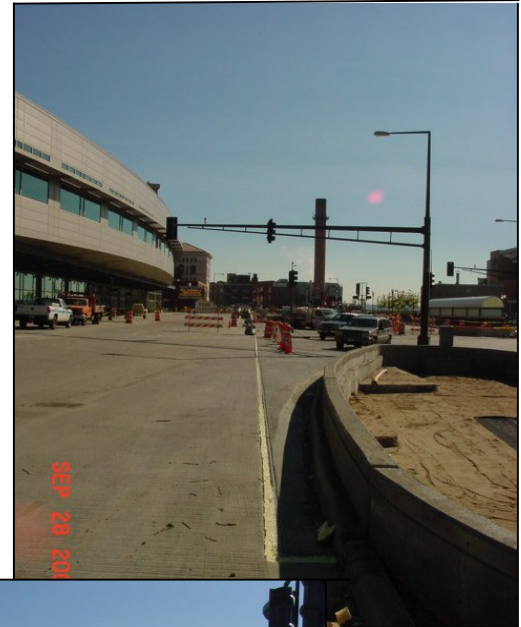
1. View of preparation in progress
2. Application in progress.
3. Close up of application
