BELZONA® SEALS CONCRETE ROOF STRUCTURE

UNIVERSITY
British Columbia, Canada

August 2003

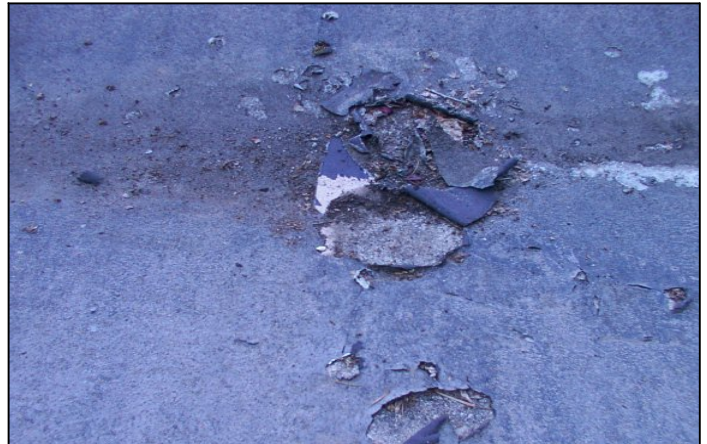
Concrete roof structure had many hairline cracks. Various products had been used over a period of time with limited success.

1. View of problem roofs
2. Close up of one of the repair areas.
3. General view of completed application.
