BELZONA® 3111 FLEXIBLE MEMBRANE SEALS SKYLIGHTS

UNIVERSITY CAMPUS
Victoria, BC

August 2003

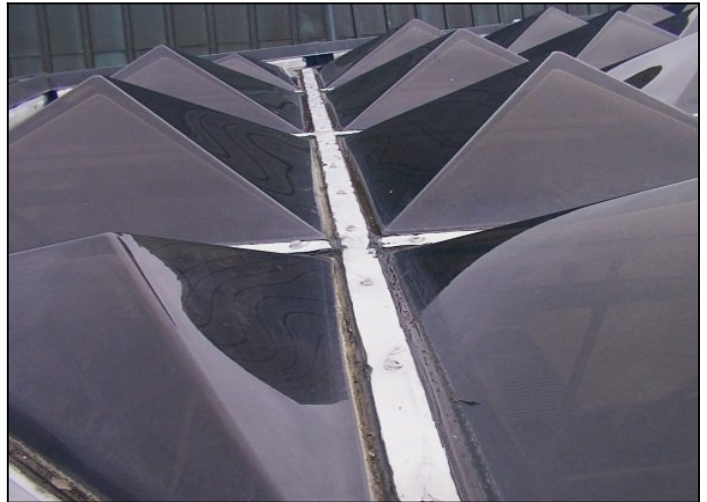
1. General view of skylight structure.
2. Close up of one of the many problem areas.
3. Completed application

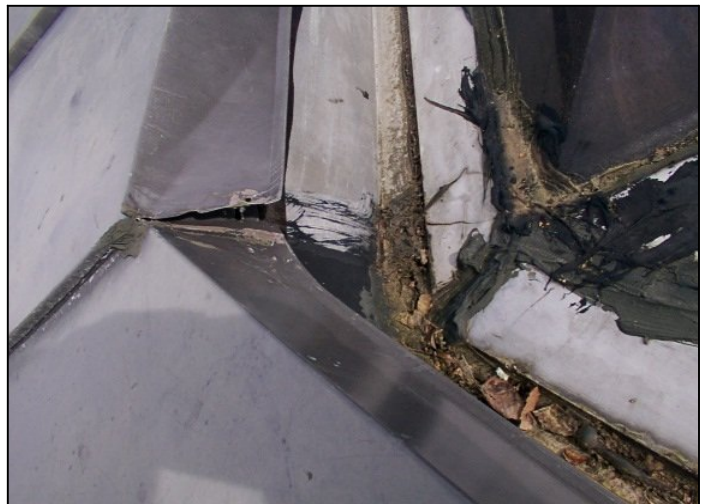
The skylights were situated over a major gathering area. Constant leaking created major safety issues and other problems
