## BELZONA® PROTECTS CHILLERS END COVERS

Telephone Company  
Burnaby, BC.

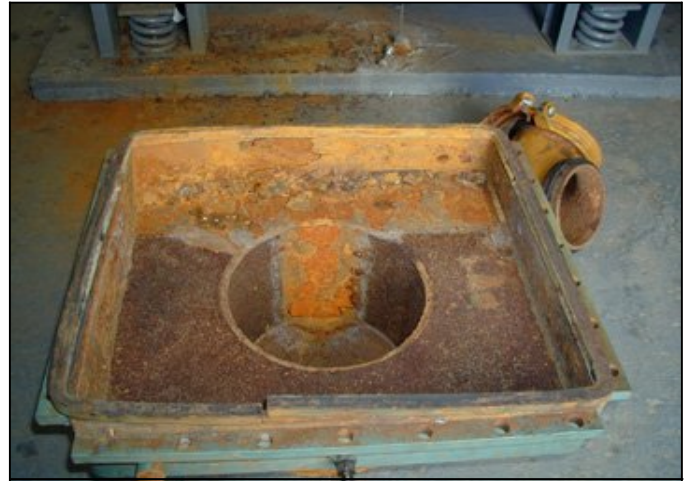
Severe corrosion pitting of metal surfaces.

1. View of eroded corroded end cover
2. Close up of end cover before grit blasting
3. Completed application.

The Belzona application isolates the two metals and eliminates the possibility of bi-metallic corrosion. The service life of tube sheets and end covers protected in this manner will be extended by a minimum of 10 years saving both downtime and replacement costs.
