BELZONA® 1000 SERIES PRODUCTS PROTECTS CHILLER

Property Management
Burnaby, BC

May 2002

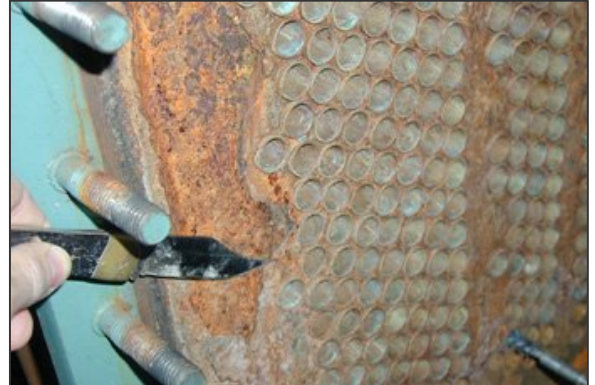
Both the tube sheet faces and the end covers were showing signs of erosion

1. First photograph shows the extent of corrosion and pitting.
2. After tube sheet face has been grit blasted to a near white metal finish SSPC SP 10
3. Tube sheet face has been rebuilt with Belzona® 1311 Ceramic R Metal and over coated with 1st coat of Belzona® 1341 Supermetalglide.
4. 2ND coat of Belzona 1341 Supermetalglide applied and tube sheet holes reamed out to ensure free passage of water through them.
