BC KHIA #020

BELZONA® FPA-8 NON-SLIP SAFETY SYSTEM APPLIED TO SLIPPERY LOG DECK

WEYERHAEUSER
Kamloops BC

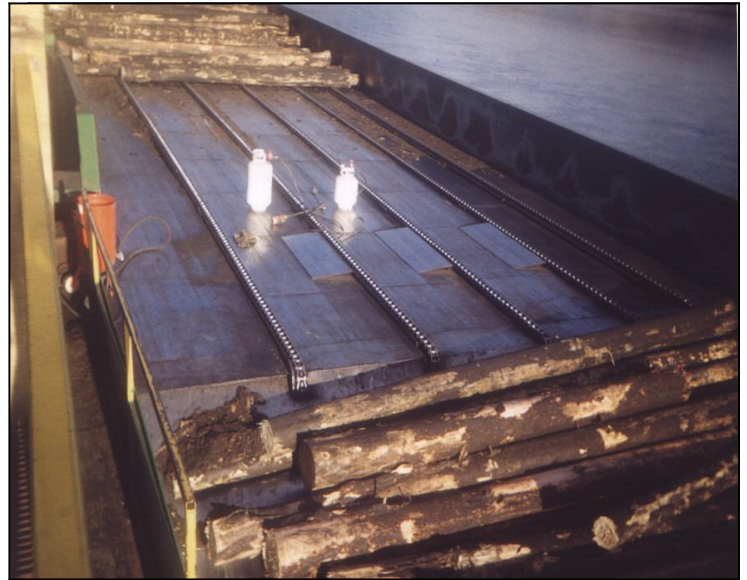
Wet steel plate extremely slippery

1. View of application situation.
2. Completed application

Application carried out in accordance with Belzona® Know-How FPA-8
