BELZONA® REBUILDS WORN CHIPPER DISC POCKETS

VARIOUS
British Columbia, Canada

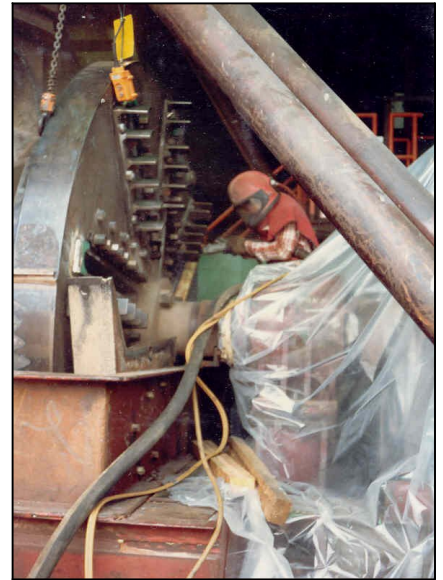
1. Grit blasting of pockets in progress
2. View of grit blasted pocket.
3. Rebuilt chipper pocket

Using Belzona® allows chipper disc pockets to be easily and quickly rebuilt without the need for welding and dismounting.

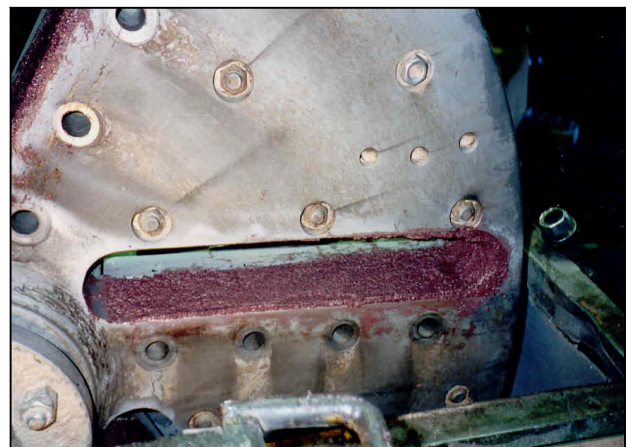
Wood chips erode the pockets at the exit point of the chipper disc.
