BELZONA® SHM-12 POSITIVE GRIP SYSTEMS IMPROVES MILL EFFICIENCY

LUMBER MILL
British Columbia, Canada

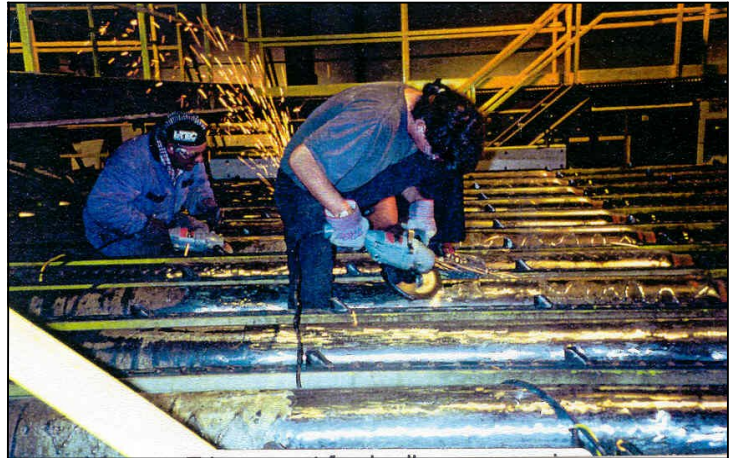
1. View of preparation in progress
2. Application in progress.
3. Completed application

Application of the Belzona® system created a positive traction on the rolls reducing slippage and short cuts
