BELZONA® SHM-12 POSITIVE GRIP SYSTEMS USED TO RE-LAG DRIVE PULLEY

Lumber Mill
Kamloops, BC.

January 1997

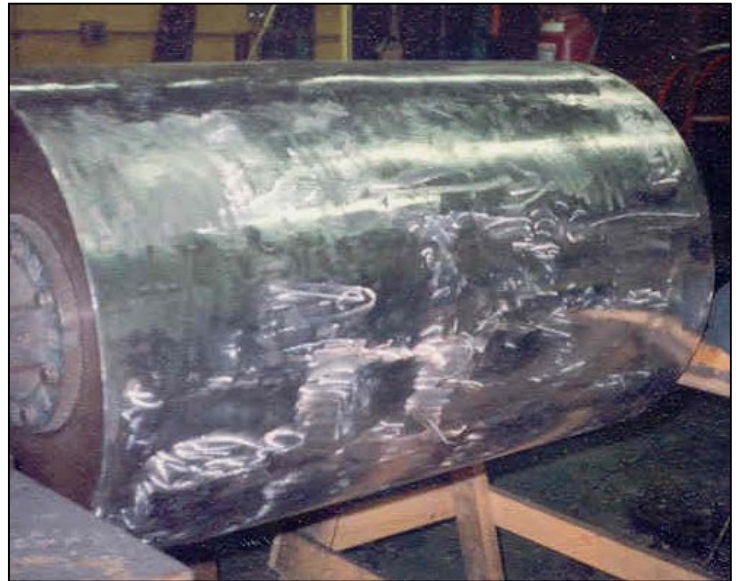
1. The original lagging has been removed and the steel surface ground to provide a rough profile onto which the Belzona product is applied.
2. Completed application. In this instance a chevron type pattern was employed to ensure that rain water (Outside application) would be swept to the outer circumferences of the roll.

The original rubber lagging was no longer effective and customer opted for Belzona because it could be done in the maintenance shop over the weekend.
