BELZONA® SHM-12 POSITIVE GRIP SYSTEMS

Saw Mill Operation
Vancouver, BC

February 2005

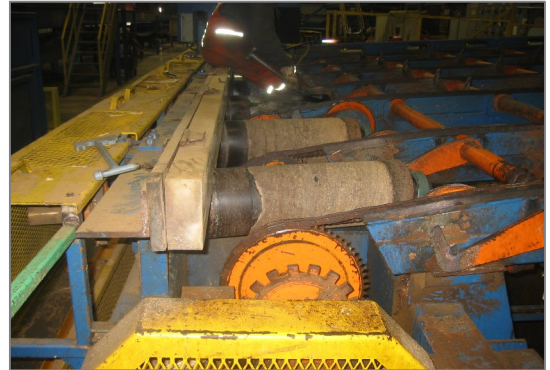
The original Belzona® SHM-12 Positive Grip System installed as OEM Equipment 6 years previously was in need of replacement. The fence had also been moved leaving a bare section on the roll.

1. View of original OEM Installation after 6 years of service..
2. A tiger torch was used to remove the old material.
3. The rolls were then ground to a clean rough profile.
4. A new Belzona® SHM-12C Positive Grip System was applied to 12 rolls on the deck
