BELZONA® FPA-8 NON-SLIP SAFETY SYSTEM STANDS THE TEST OF TIME

Particle Board Manufacturer
Grand Forks, BC

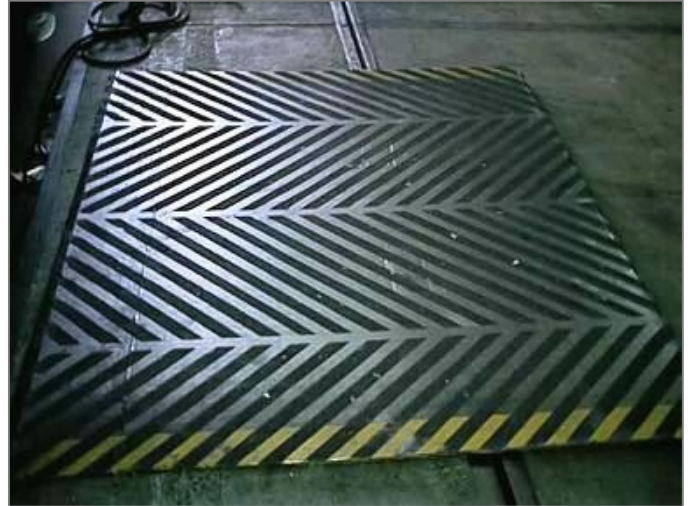
1. View of complete application taken after approximately 6 months service.
2. PHOTOGRAPH OF THE RAMPS TAKEN AFTER IT HAD BEEN IN SERVICE FOR 2 YEARS.
3. **CONDITION OF RAMPS AFTER 5 YEARS OF CONSTANT HEAVY DUTY SERVICE 24/7**

The application was inspected after 3 years of constant service, and found to remain in excellent condition, even with no maintenance. Beyond the improved safety, additional benefits were the fact that forklift operators can effectively push the last load into the rail car for more secure loading. Prior to the Belzona application, the forklift drive wheels would spin on the steel plate during this operation, but the Belzona Grip System prevents the wheels from spinning and allows the last load to be pushed firmly into place
