## BELZONA® 1812 PROTECTS HOG FUEL ELBOWS

Lumber Mill  
Castlegar, BC

May 2006

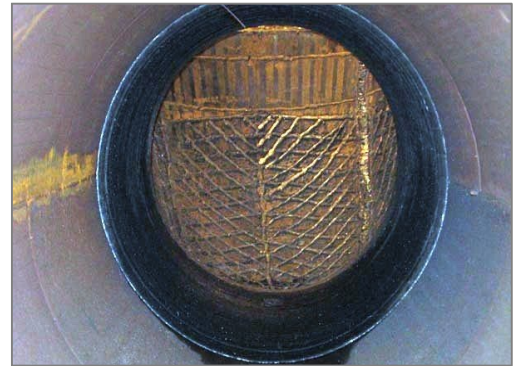
Hog fuel would hang up on the hardened steel welds used to protect the surfaces from excessive erosion.

1. View of elbow showing application area and hardened welding.
2. Area rebuilt with Belzona 1812 Ceramic Carbide FP
3. Rebuild completed.
4. Area overcoated with Belzona 1321 Ceramic S Metal to provide an extra degree of smoothness.
