BELZONA® EFFICIENCY COATING FOR JET DUCTS

CUSTOMER
FERRY OPERATOR
Vancouver, BC.

August 1999

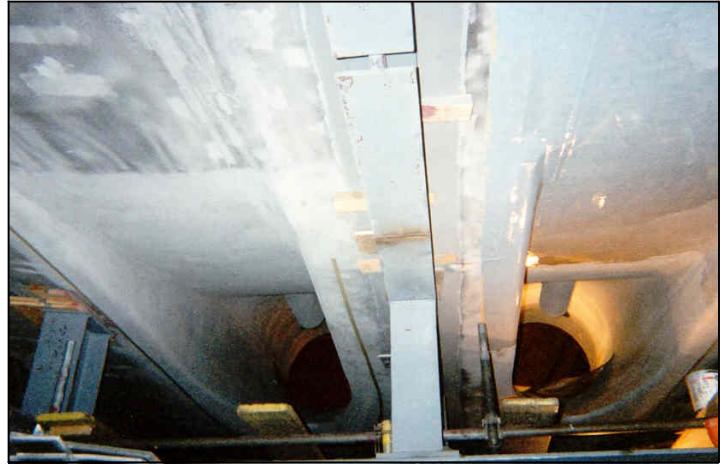
1. View of ducts after grit blasting
2. Application of 1st coat in progress
3. 2nd coat completed
