BELZONA® REBUILDS OVERSIZE PIN BUSH HOUSING

Mining Group

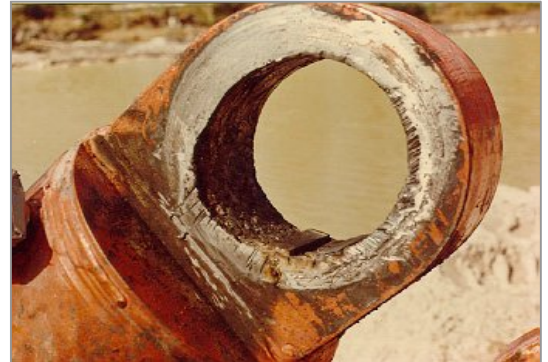
The bush housing had worn oversize

1. Oversize Housing.
2. Outer race used as a former
3. Trial fit
4. Completed application .
