BELZONA® 1811 CERAMIC CARBIDE EXTENDS LIFE OF PUMP CASING

Gravel and Aggregate Producer

June 2000

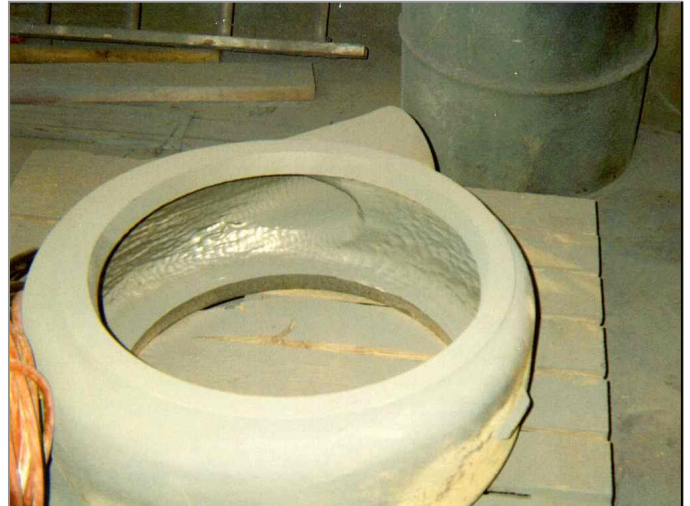
1. View of Pump
2. Close up of pump showing extent of erosion
3. The internal surfaces of the pump casing are protected with Belzona 1811 Ceramic Carbide.

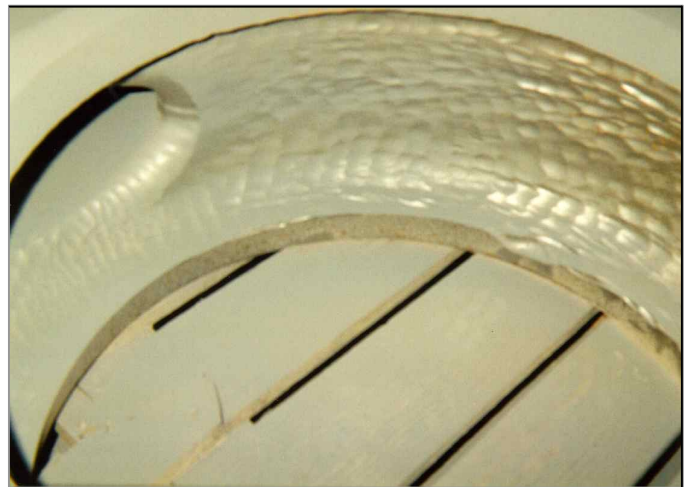
Pumping drainage water from a gravel pit has a high percentage of entrained solids causing major erosion damage to pumps
