## BELZONA® 2000 SERIES PRODUCTS SEAL SF<sub>6</sub> LEAKS

SF<sub>6</sub> gas leaking from the joint between the metal base and the porcelain insulator

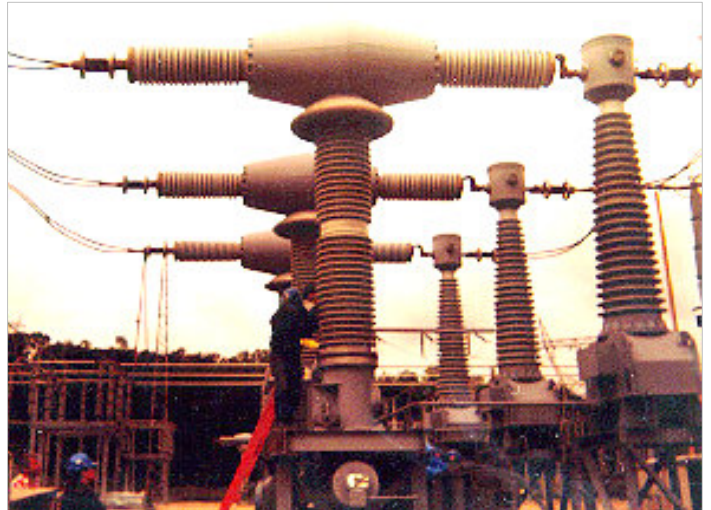
1. View of sub station
2. After preparation of the base a metal ring coated with release agent was clamped around the circumference of the unit to form a "dam".
3. Belzona® 2221 MP Fluid Elastomer was pored into the "dam" and allowed to set up before the metal ring was removed a few hours later.
