BELZONA® PROTECTS HOG FUEL AUGER

PULP & PAPER OPERATION
Powell River, BC

Erosion of metal on hog fuel auger flights.

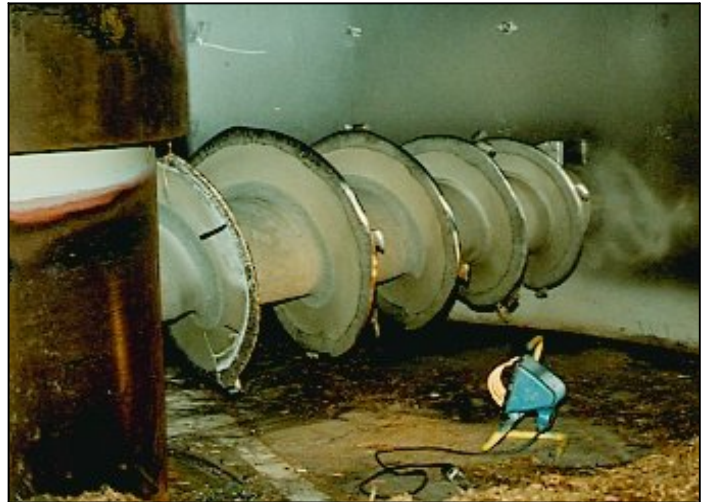
1. View of auger in working environment
2. Close up of rebuild area.
3. Completed application
