## BELZONA® EXTENDS LIFE OF ID FAN HOUSINGS

Pulp & Paper operation  
Port Alberni, BC

July 2004

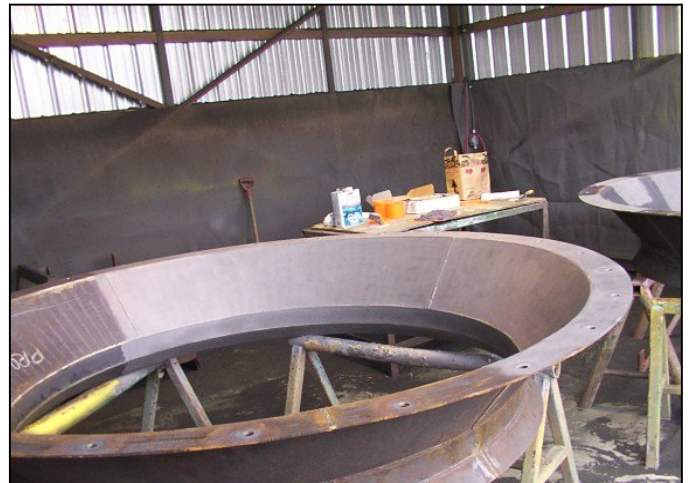
1. New housing grit blasted to achieve a rough profile.
2. Application of Belzona® 1812 Ceramic Carbide FP in progress
3. Completed application to 2 new housings.

Application carried out in accordance with Belzona® Know-How Leaflet SHM-1
