BELZONA® PROTECTS REPULPER FROM ABRASION

Pulp & Paper Operation
Powell River, BC

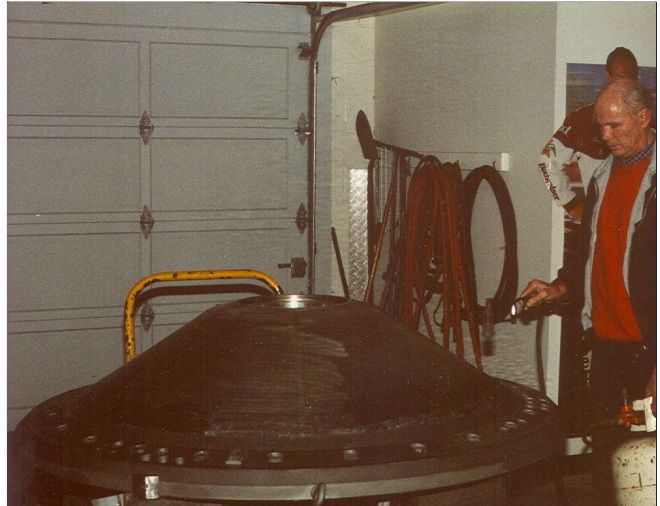
1. Preparation in progress. Component heated to assist in removal of moisture
2. Preparation completed and application in progress.
3. Completed application.

Belzona® was applied as a sacrificial coating to the outer circumference
