BELZONA® 1321 CERAMIC S METAL PROVIDES PROTECTION AND TRACTION

Pulp Company
Celgar, BC

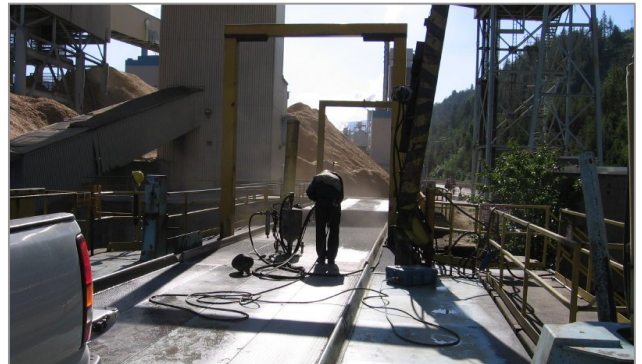
1. Preparation of the steel surface in progress by grit blasting.
2. Mixing of product in progress
3. Application of product to blasted surfaces in progress.
4. Completed application.
