BELZONA® 1341 SUPERMETALGLIDE IMPROVES PUMP PERFORMANCE

OEM PUMP MANUFACTURER

August 1996

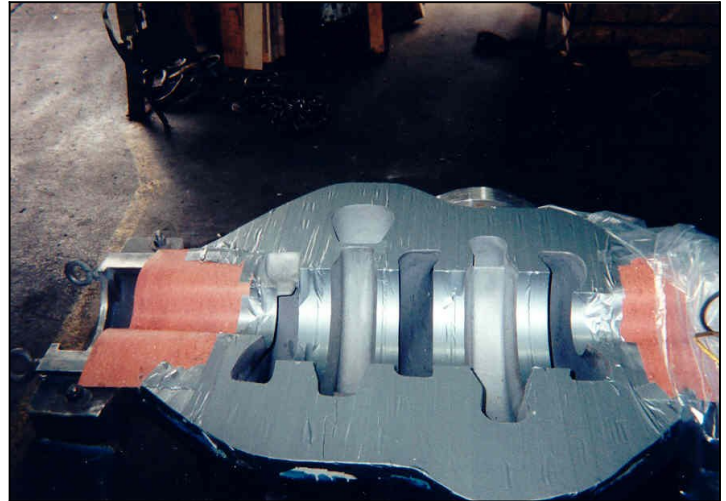
1. Pump casing grit blasted and ready for application of 1st of 3 coats. 1st coat applied was Belzona® 1321 Ceramic S Metal.
2. Application of 2nd coat Belzona® 1341
3. 3rd and final application of Belzona® 1341

These pumps were part of a 45 pump contract for a Canadian inter provincial pipe line company. (Pumps were built in 2 locations –Vancouver, BC & Portland, OR. Tests on a pilot unit had shown that coating with Belzona® 1341 improved overall performance by approximately 1½ - 2%. This was considered worthwhile as it provided the extra pumping margin required by the customer. Every pump was pre- assembled tested to establish pump curve, disassembled, grit blasted , coated, and then reassembled before re-testing. In all cases performance curve had improved.
