## **BELZONA® 1811 CERAMIC CARBIDE EXTENDS LIFE OF PUMP CASING**

Gravel and Aggregate Producer

Pumping drainage water from a gravel pit has a high percentage of entrained solids causing major erosion damage to pumps

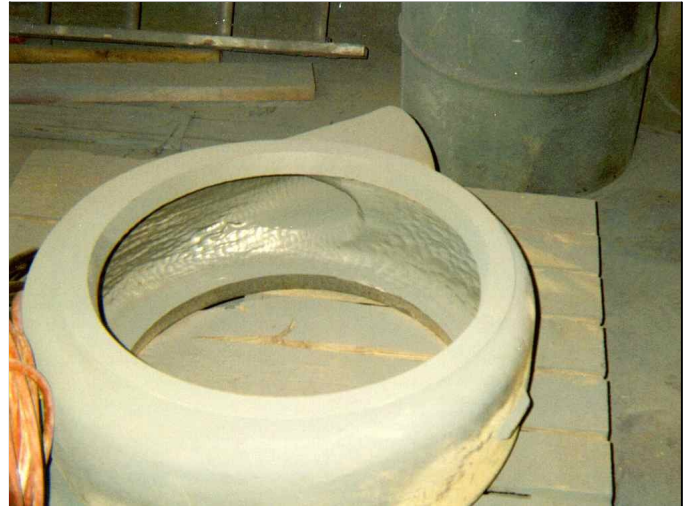
1. View of Pump
2. Close up of pump showing extent of erosion
3. The internal surfaces of the pump casing are protected with Belzona 1811 Ceramic Carbide.
