BELZONA® GIVES POOL MAINTENANCE OFFICE A LIFT

Recreation Center
Burnaby, BC.

April 2005

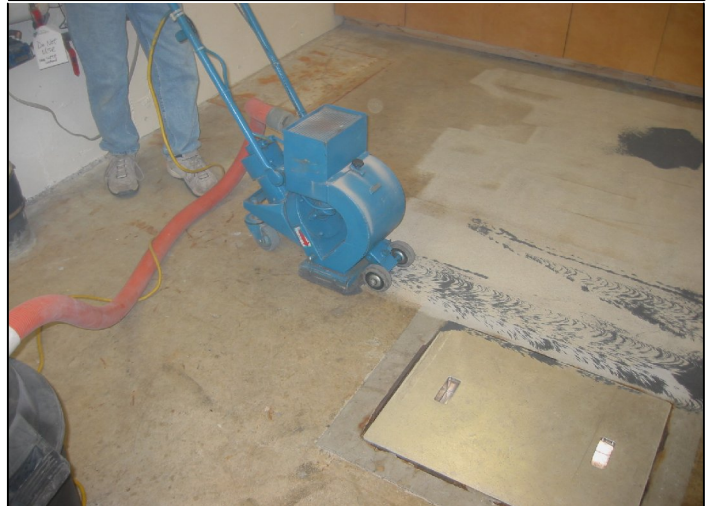
1. Preparation of floor surface in progress with Vacublast unit.
2. Preparation and masking completed.
3. Two coats of Belzona® 5231 SG Laminate applied
