## BELZONA® ELASTOMERS SEAL OLYMPIC SIZE POOL

Recreation Center  
Langley, BC.

September 2005

Original expansion joint material had failed in many places

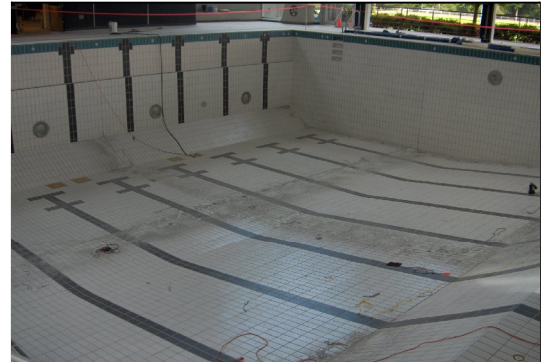
1. Preparation underway in the deep diving end of the pool.
2. A section of the 100m x 50m Olympic size pool prepared and masked off ready for the application of Belzona® 2221 MP Fluid Elastomer.
3. View of the completed recreation pool
4. View of completed expansion joints.
