BELZONA® 4000 SERIES PRODUCTS RESURFACE STAIRS

Recreation Center
West Vancouver, BC

August 2006

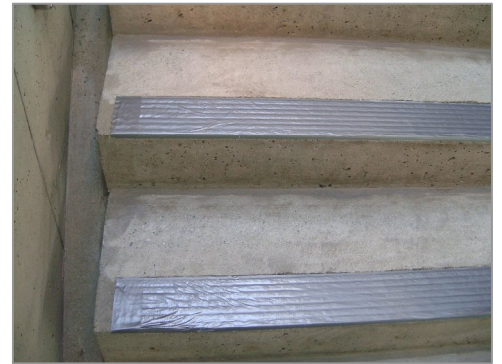
1. Preparation of the concrete surface completed using a Bosch Vacu-grinder.
2. All step risers were resurfaced with Belzona® 4111 Magma Quartz.
3. Steps were pre-coated with a slurry mix of Belzona® 4111 Magma Quartz Aggregate and Belzona 4911 TX Conditioner then dusted with dry Magma Quartz Aggregate to produce an even grey non-slip type surface and allowed to set overnight.
4. The excess aggregate was brushed off leaving a fine non-slip surface.
