## BELZONA® PROTECTS WASTEWATER PIPES FROM ABRASION

Wastewater Treatment Facility  
British Columbia

June 1998

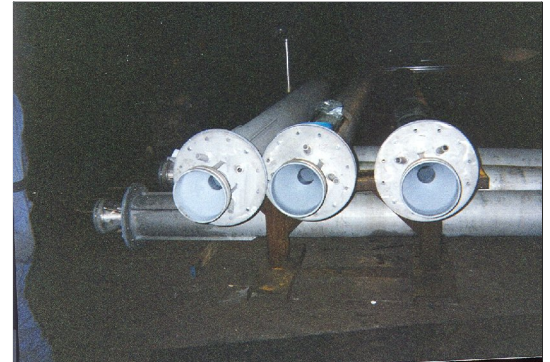
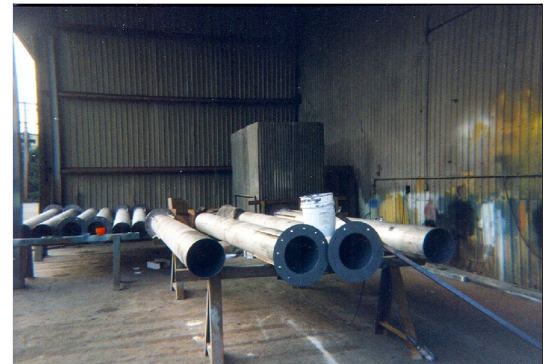
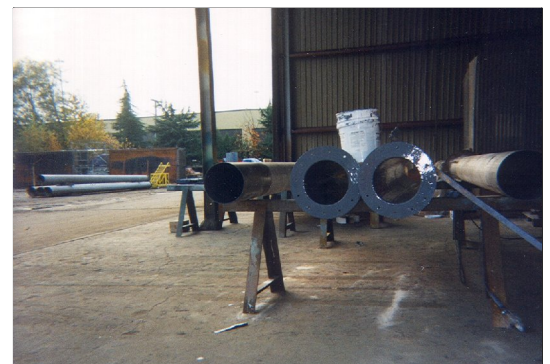
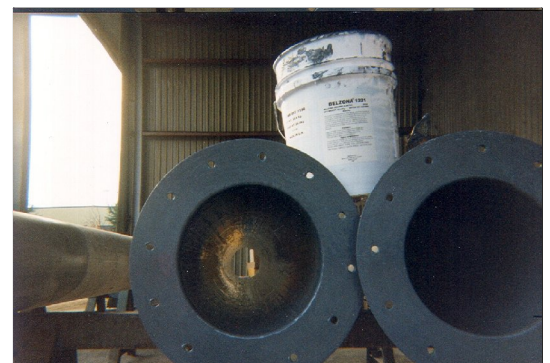
- 1-4 View of various stages of the application. Project consisted of 14 12ft x 12in diameter pipes all with housed matching venture assemblies. The main pipes were coated on the inside only, while the venture assemblies were completely protected with 2 coats of Belzona® 1321 Ceramic S Metal

Application of Belzona® 1321 Ceramic S Metal helped retard the abrasion process significantly in previous test applications
