BELZONA® PROTECTS RUBBER PIPES FROM UV ATTACK

Wastewater Treatment Plant
Nanaimo, BC.

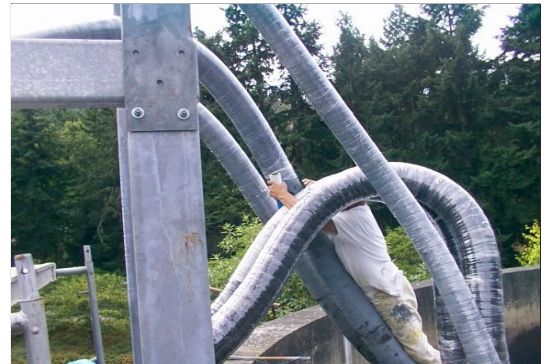
1. Application in progress. Rubber pipes are first wrapped tightly with plastic foil. This eliminates a possible leaching discoloration problem that occurs when overcoating rubber.
2. All stainless steel flanges are coated with Belzona® 3921 GSC Conditioner
3. Application of 1st coat of Belzona® 3211 in progress.
4. Application completed.
