For Repair and Prevention of Corrosion Under Insulation (CUI)

BELZONA®
1251/5851
HA - METAL / HA - BARRIER

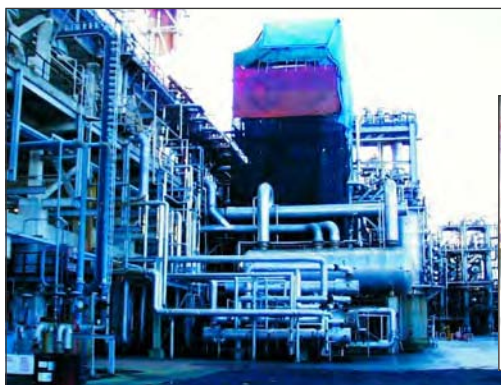
INSULATED INSTALLATION APPEARS SOUND

... UNDERNEATH - THE REALITY

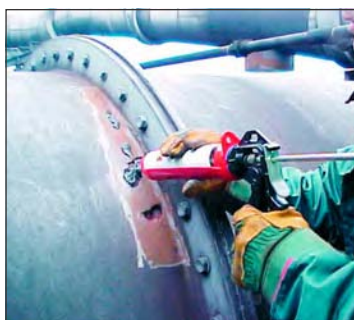
INFILL CORROSION PITS

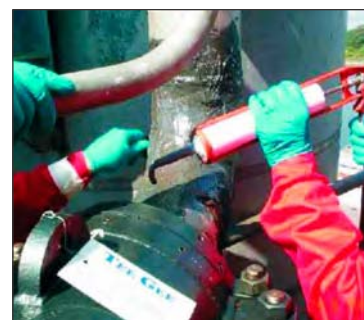
LOCAL REPAIR

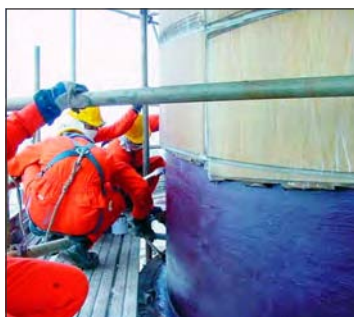
PROTECTION OF PROCESS VESSELS

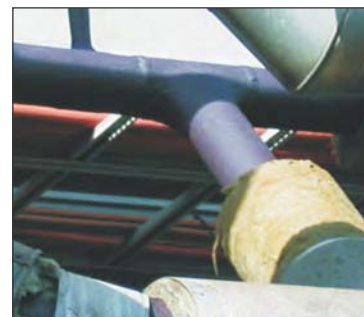
PROTECT PIPEWORK

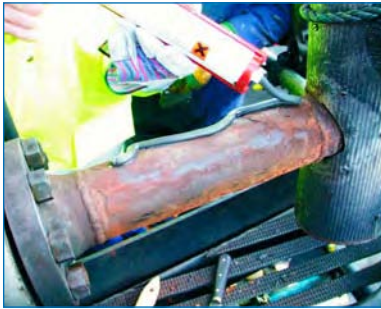
Belzona® 1251 - Rebuilding grade product designed to infill corrosion pitting and for bonding doubler plates over badly corroded areas.

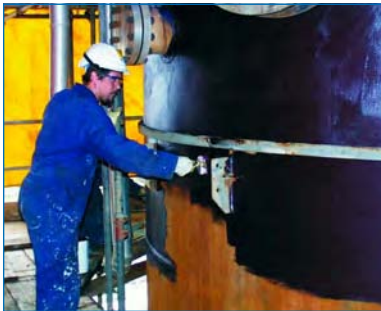
Belzona® 5851 - Coating grade that provides outstanding corrosion protection.
